**U.S. ENVIRONMENTAL PROTECTION AGENCY
REGION III
CLEAN WATER ACT
COMPLIANCE INSPECTION REPORT**

Name of Facility: Super Salvage, Inc.
Facility Address: 1711 1st St SW Washington, DC 20024
Mailing Address: 1711 1st St SW Washington, DC 20024

Inspection Date: February 20, 2013
Entry Time: 1:40 pm EST
Exit Time: 3:30 pm EST

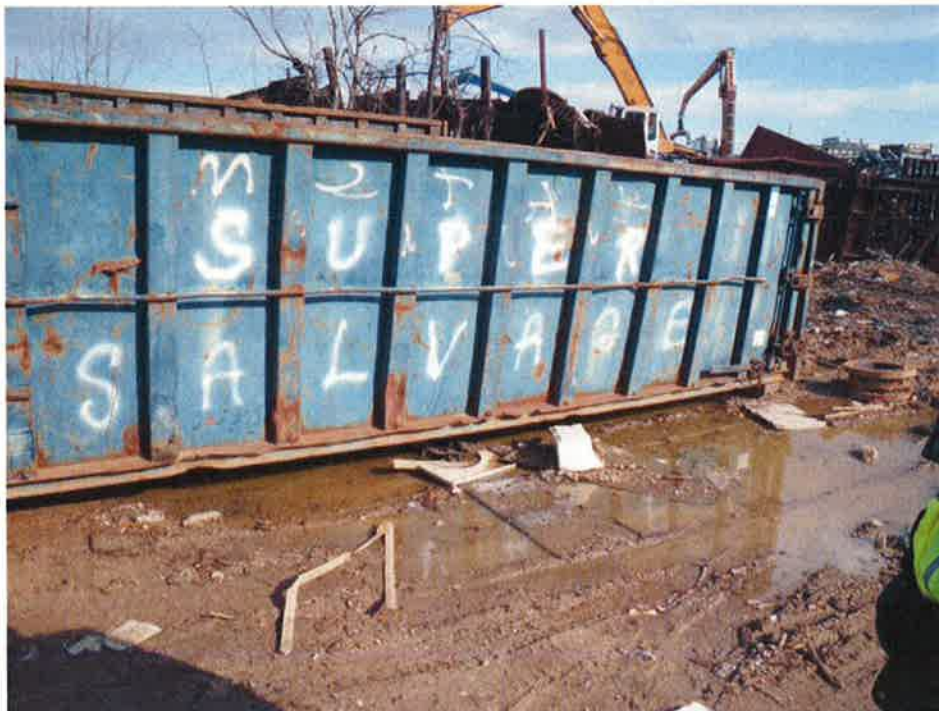
Observation 2: The EPA inspection team observed a number of spills and no active cleanup of those spills. The EPA inspection team observed what appeared to be oil and/or chemical layer floating on the surface of the large runoff collection pond. A saturated absorbent sock was observed adjacent to the pond (see Photographs 38-40 in Appendix B); however, the facility did not have active mitigation measures in place to remove the layer floating on top of the large collection pond. The EPA inspection team also observed vehicle air conditioning units placed on the ground and leaking fluids; however, no absorbent materials were placed on the leaking fluids (see Photographs 48-50 in Appendix B). The EPA inspection team observed what appeared to be oil staining outside of the perimeter berm (see Photographs 75 and 78 in Appendix B), sediment residue and liquids on District of Columbia (DC) streets outside/near entrance 2 (see Photographs 61 and 62 in Appendix B) and drainage from Super Salvage's open-top dumpsters located on, according to Mr. Bullock, DC property adjacent to the facility fence line (see Photographs 63 and 64 in Appendix B).

The EPA inspection team observed storage of sorted metal, engine parts, car batteries, leaking air conditioning units, and hydraulic equipment in various uncovered areas throughout the facility as well as on the property, that according to Mr. Bullock, is owned by DC (see Photographs 16, 24-28, 32-38, 41-45, 48-50, 63, and 64 in Appendix B).

Photograph 64. Super Salvage metal dumpsters and pooled water. Dumpsters are located on DC property adjacent to the Super Salvage fence line.

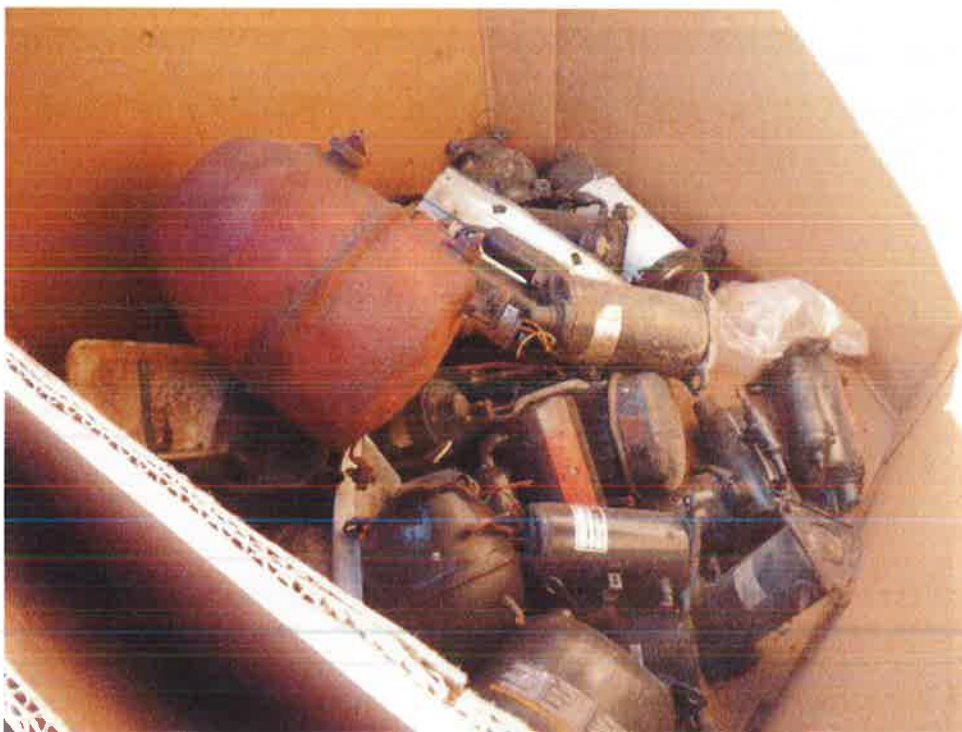
Observation 5: The EPA inspection team observed storage of what appeared to be lubricants and used oil filters in metal drums in various locations on site (See Photographs 3, 4, 15, 17, and 70 in Appendix B). Scrap engine parts were stored in cardboard boxes (see Photographs 65 and 66 in Appendix B). A 500-gallon diesel fuel tank was stored near Entrance 2. The diesel fuel tank was located in a high-traffic area with no barricades and was immediately adjacent to several oxygen tanks and propane tanks (see Photograph 53, 54, and 57 in Appendix B). When asked, Mr. Bullock was unsure if the oxygen and propane tanks were full or empty. The EPA inspection team did not observe secondary containment measures in place around the diesel fuel tank and small propane tanks. The EPA inspection team also observed additional fuel storage tanks including a 500-gallon diesel storage

Photograph 66. View of inside of box with staining shown in Photograph 65. Box contains engine parts.

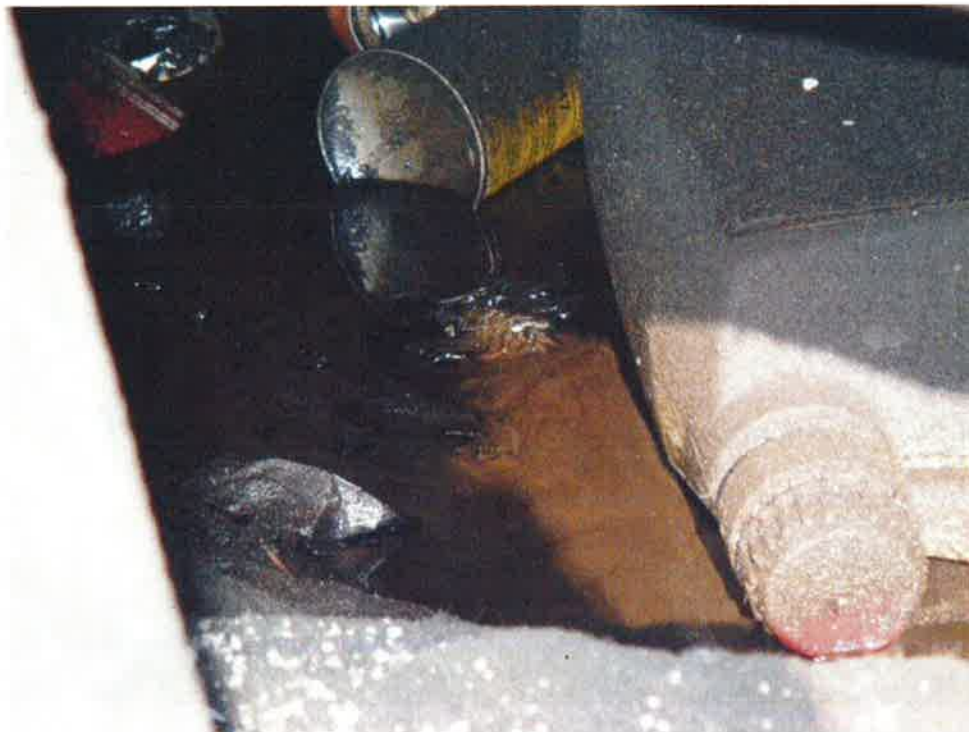
Observation 6: The EPA inspection team observed what appeared to be oil staining and pools of oil present throughout the facility (see Photographs 67 and 68 in Appendix B). In some cases saturated absorbent material was present on top of the fluid (see Photograph 70 in Appendix B). The EPA inspection team observed leaking air conditioning equipment adjacent to the property fence line (see Photographs 48, 49, and 50 in Appendix B). As stated in observation 3, the EPA inspection team observed the inside of a small building containing hydraulic equipment. The floors had saturated absorbent material located near the drums and hydraulic equipment, in addition to pooled fluids underneath the hydraulic machinery (see Photographs 20-23 in Appendix B).

Photograph 68. Close-up view of what appears to be oil pooling under tanks.

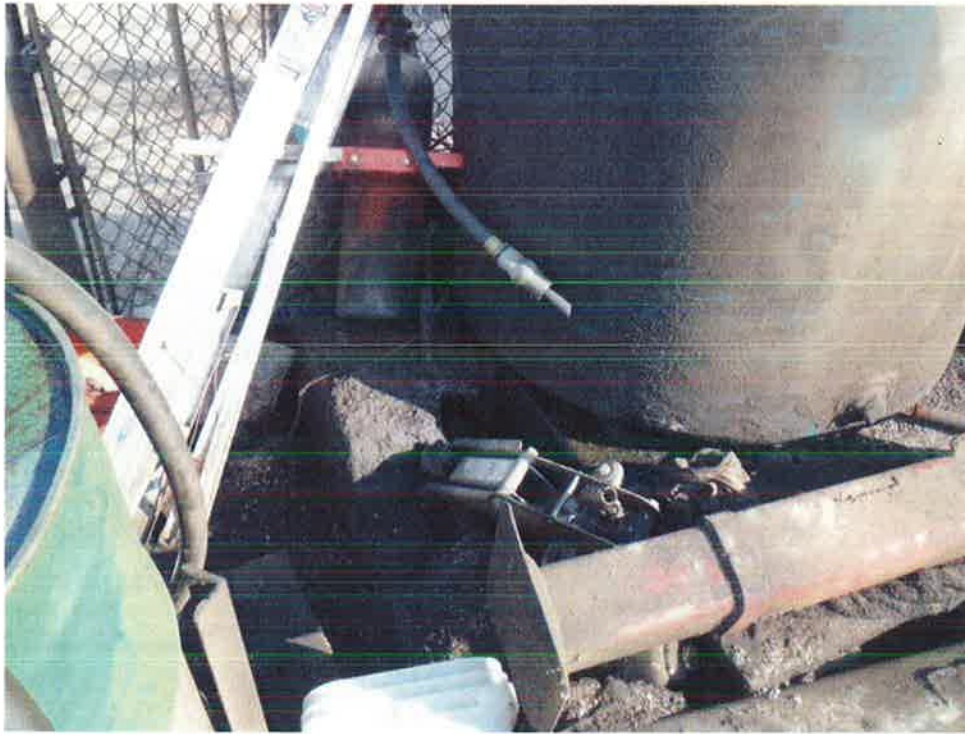
Photograph 69. **Wide view of tanks near Entrance 1.**

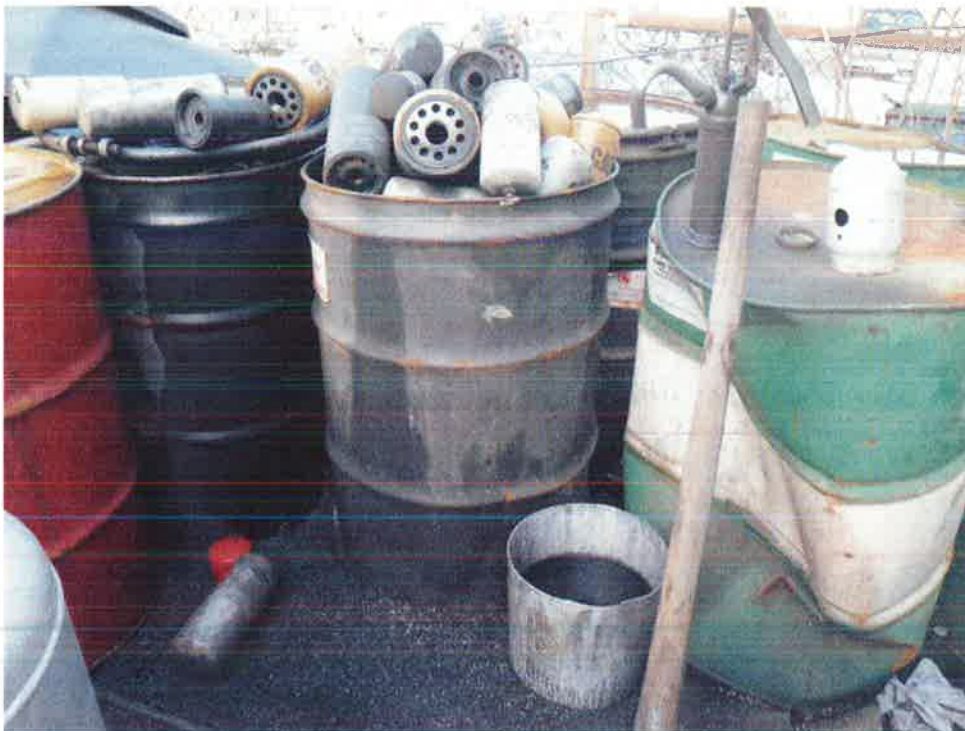
Observation 4: Super Salvage stored what appeared to be its used waste oil in an unlabeled plastic bin near Entrance 1 (see Photographs 71 and 72 in Appendix B). Several unlabeled open buckets and drums that were labeled as lubricants were also stored by the entrance on wooden pallets. It was unclear to the EPA inspection team whether the contents inside of these drums were lubricants (see Photographs 3, 4, and 70).

Photograph 70. **View of open buckets and storage drums containing used oil filters on top of secondary containment covered in absorbent material.**

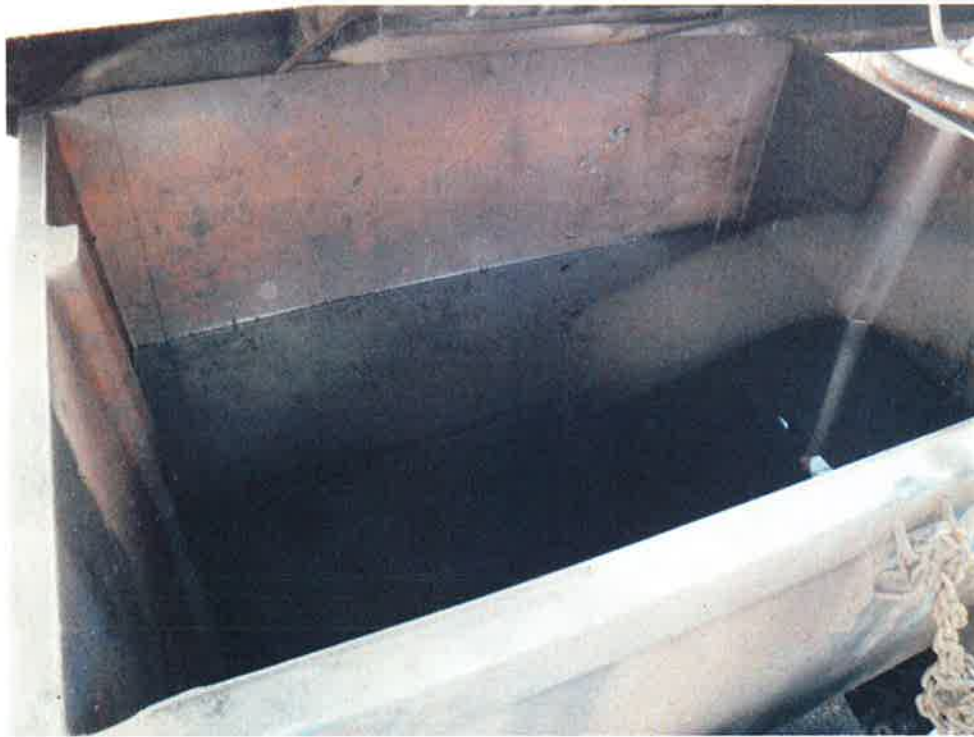
Photograph 71. Plastic container/dumpster of what appears to be waste oil adjacent to the property boundary.

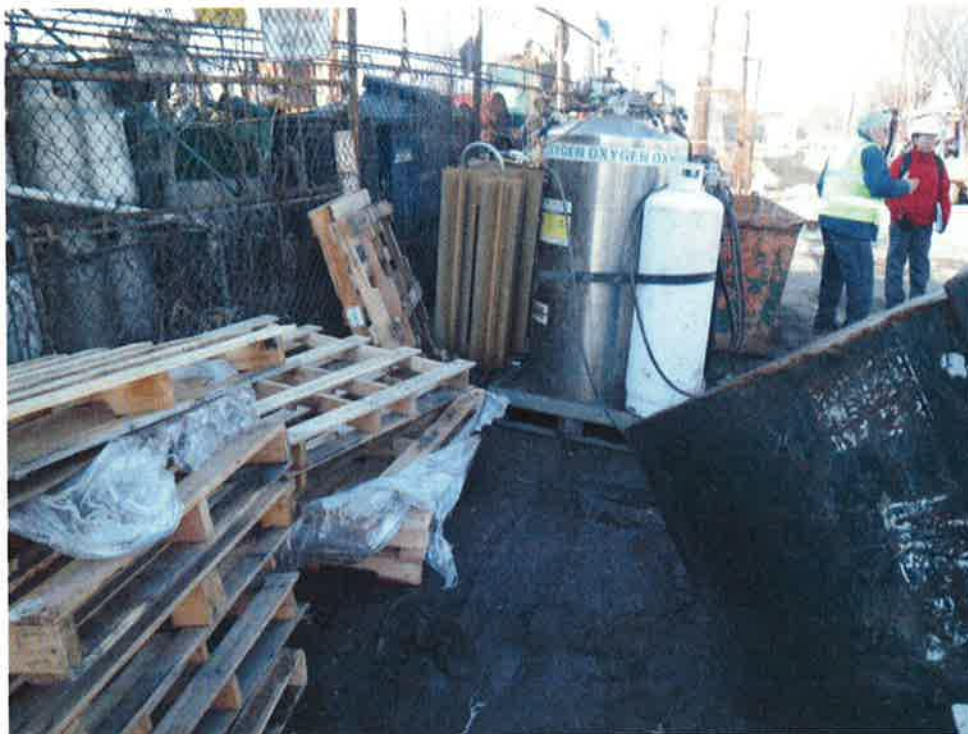
According to Mr. Bullock, there are no stormwater outfalls at the Facility and the site is designed so that stormwater does not leave the site. The perimeter of the site has a concrete curb, Entrance 1 has a berm, and Entrance 2 slopes into the Facility (see Photographs 2, 50, and 53 in Appendix B). However, in many cases, the EPA inspection team observed materials stored outside the perimeter of the Facility (see Photographs 58, 63, and 75 through 78 in Appendix B), sediment/material/liquid residue in and around the entrance and outside of the site (see Photographs 1, 3, 47, 50, 56, 61, 73, 75, 80, 83 and 84 in Appendix B), and there was evidence of what appeared to be oil staining and fluid losses beyond the curbing and berm and sediment into the storm drain near the corner of First Street SW and S Street SW (see Photographs 75, 79, 80, 81, 83, and 84 in Appendix B).

Photograph 75. **Staining on the ground outside of the perimeter fence near dumpsters.**

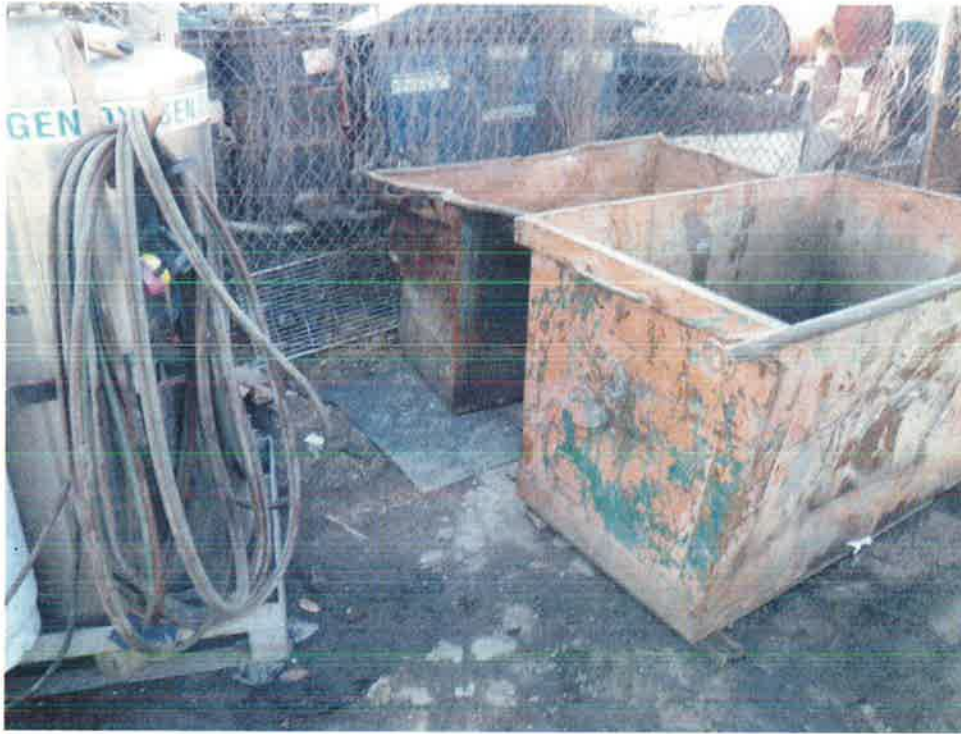
Photograph 76. **View of items stored the outside of the perimeter fence.**

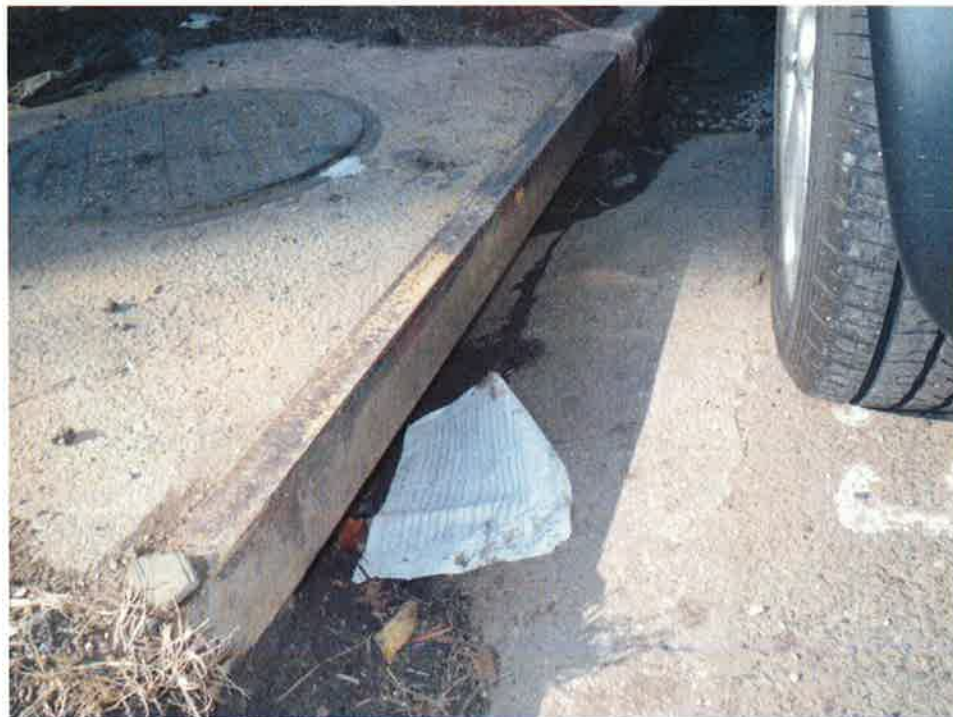
Observation 8: A Google Earth® map dated October 2012 shows sediment residue at both Entrance 1 and Entrance 2 of the site (see Site Map in Appendix A). During EPA's inspection of Super Salvage and the surrounding roadways, the EPA inspection team observed sediment residue on DC streets near both entrances and

Photograph 79. Path of sediment leading from Super Salvage towards the storm drain.
Storm drain is located near the corner of First Street SW and S Street SW.

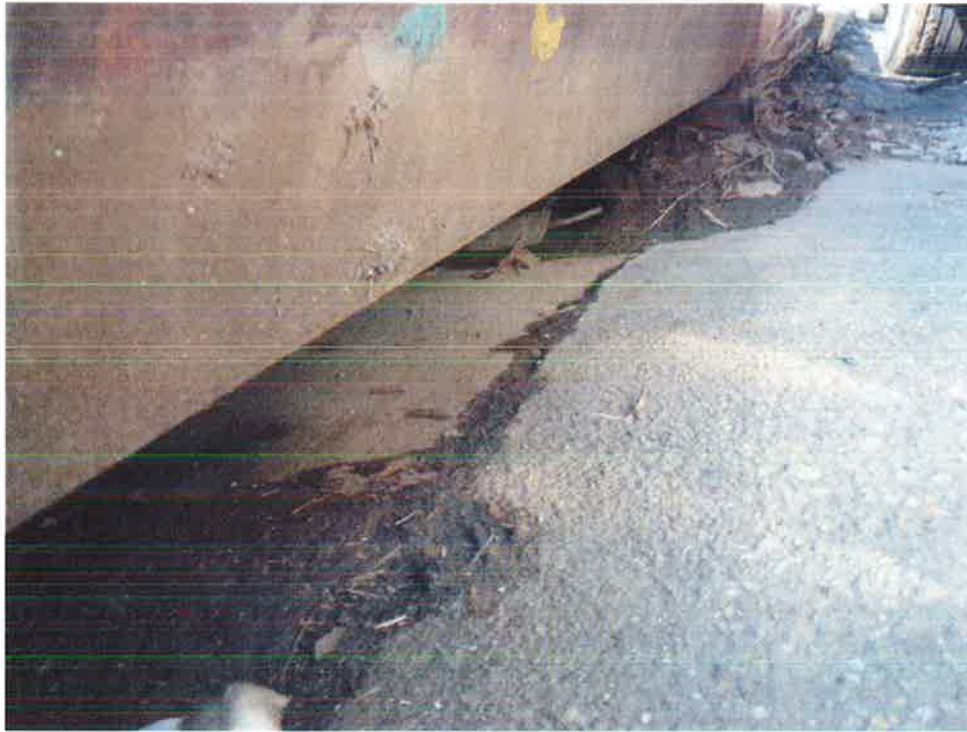
Photograph 80. View of storm drain closest to site near the corner of First Street SW
and S Street SW.

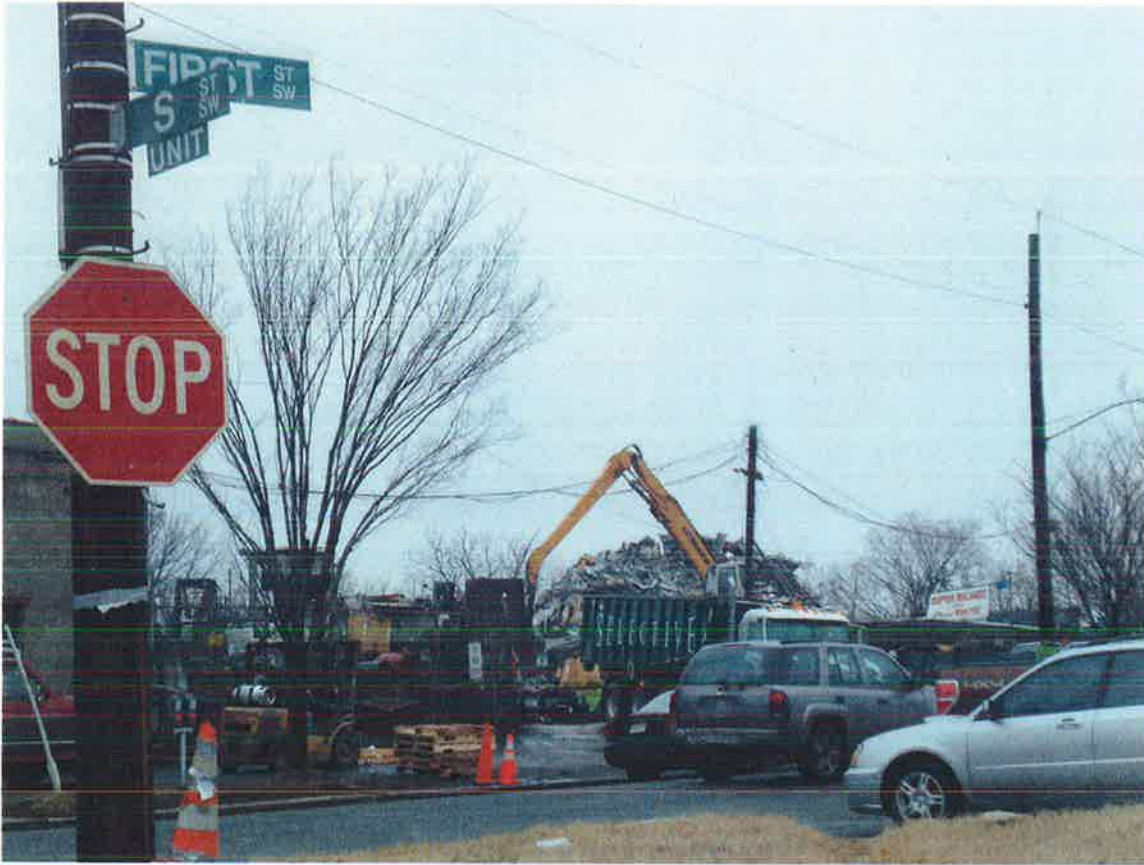
Photograph A. View toward entrance 1 of Super Salvage, Inc. from the corner of First Street SW and S Street SW.

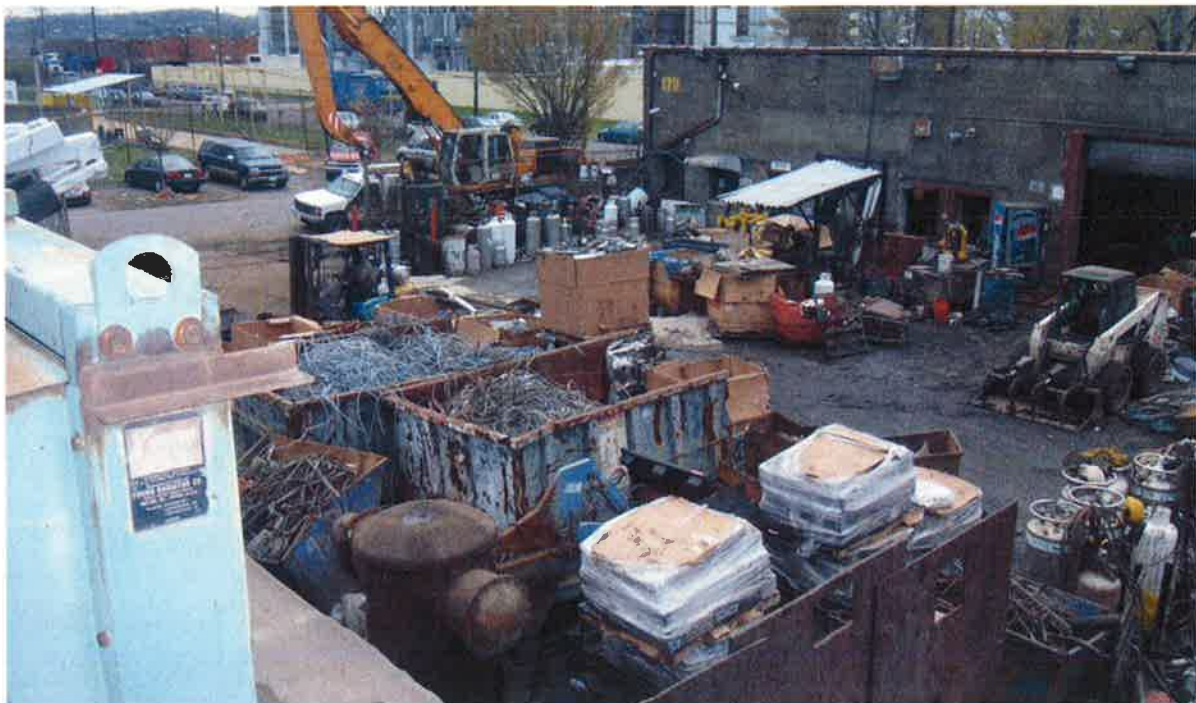
View of property
